Journal section: Endodontics
Publication Types: Research

Impact of different gutta-percha removal techniques on dentinal integrity: An *in vitro* analysis

Guedes OA, Ferreira HC, Abreu DM, de Lima KS, Souza EM, de Freitas YG, Decurcio DA, Estrela C. Impact of different gutta-percha removal techniques on dentinal integrity: An *in vitro* analysis. J Clin Exp Dent. 2025;17(2):e195-203.

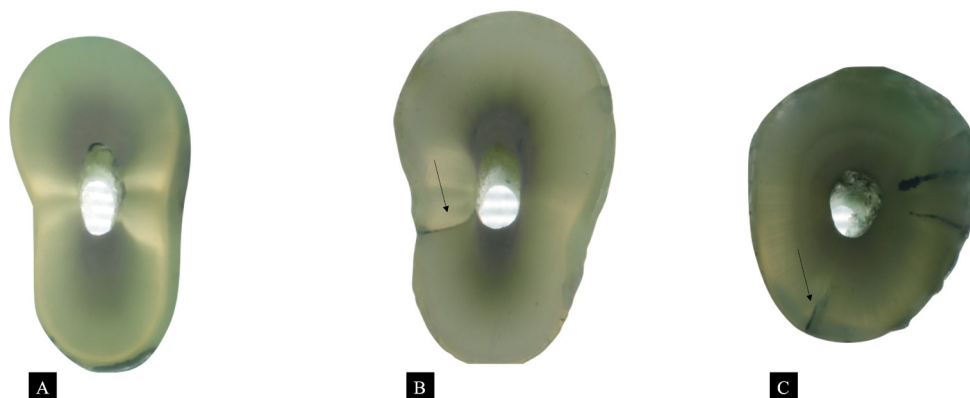
Fig. 1: Representative images of dentin slices: (A) Dentin slice without defects; (B) Dentin slice showing a root fracture (indicated by a black arrow); (C) Dentin slice showing a partial crack (indicated by black arrows).

"No defect": Root dentin without any craze lines or microcracks, where both the external root surface and the internal canal wall showed no defects (Fig. 1A).

"Fracture": A line extending from the root canal space to the outer root surface (Fig. 1B).

"All other defects": Partial cracks (extending from the root canal wall into the dentin without reaching the outer surface) and craze lines (extending from the outer surface into the dentin but not reaching the canal lumen or from the outer surface or canal wall into dentin) (Fig. 1C).
